# PHASE I INSPECTION REPORT

## NATIONAL DAM SAFETY PROGRAM

COLEMAN FALLS DAM  
AMHERST COUNTY, VIRGINIA  
INVENTORY NO. 05918

Name of Dam: Coleman Falls  
Location: Amherst County, Virginia  
Inventory Number: VA 00903

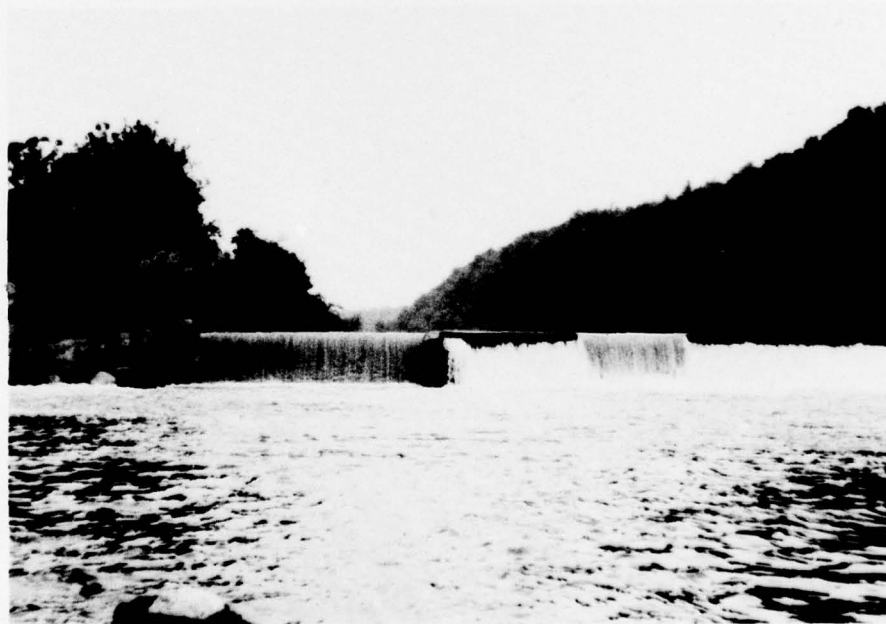
PHOTOGRAPH NO. 2  
Front View

3.1.2 Dam: The dam appears to be in good condition. A crack and several missing stones were noticed in the dam about 65 feet from the remains of the turbine building where the dam makes a 90° turn. The seepage through this crack is significant (approximately 5 gpm), however, due to its inaccessibility no measurement of flow was made (see Photograph No. 2, Appendix II.)

**7.2 Recommended Remedial Measures:** The inspection revealed some seepage and missing rocks which should be monitored as part of the regular maintenance program. It is recommended that the owner perform a more detailed inspection to insure that no other significant deficiencies exist before converting the dam to hydroelectric use.

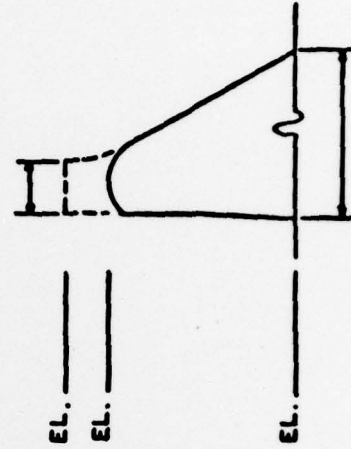
PARTIAL SECTION

LOADING CASE	ELEV. HEAD WATER	ELEV. TAIL WATER	$\Sigma V$	$\Sigma H$	$\frac{\Sigma H}{\Sigma V}$	LOCATION RESULTANT FROM TOE	% BASE IN COMPRESSION	FACTOR SAFETY SLIDING	FOUNDATION PRESSURE	
									TOE	HEEL
NORMAL POOL	589.0	572.0	33.3 <sup>k</sup>	12.2 <sup>k</sup>	0.37	7.9'			2.8 <sup>ksf</sup>	0.1 <sup>ksf</sup>
1/2 PMF	624.8	617.0	25.6 <sup>k</sup>	25.7 <sup>k</sup>	1.0	7.7'			2.2	0
